# Ash Pond Clean Up Solutions

## Environmental - Case Study

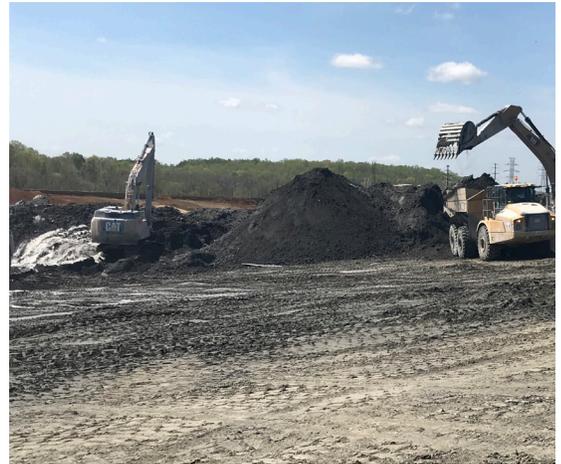
Pebble Lime being mixed in the Ash by an Excavator

Pebble Quicklime (7/8"x0") was delivered to the project via dump trucks. The pebble quicklime was then mixed with wet stock piles of excavated ash and allowed to "cook" for a short period time to drive off excess moisture. Once again, after this process was complete the ash was transported to the landfill for proper disposal.

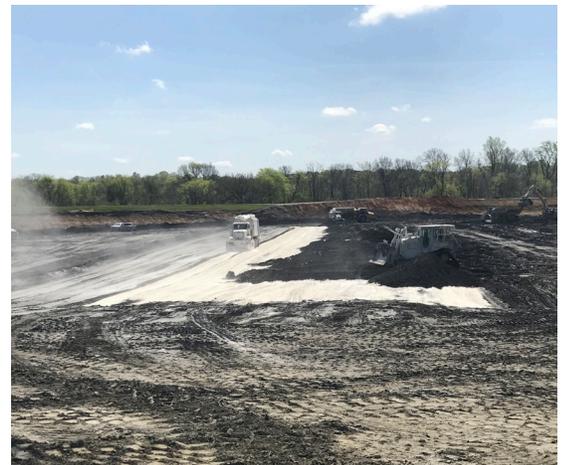
Lime Fines being spread by a Spreader Truck

Quicklime fines were delivered via pneumatic trailers and pumped into either storage pigs or directly into the spreader trucks. The spreader trucks would spread the Quicklime fines onto the wet ash and were then followed by mixing machines to incorporate the ash and quicklime together to produce a homogeneous mix. Within an hour, the reaction between the Quicklime and wet ash was complete and the ash was then loaded onto off-road dump trucks and transported to the on-site landfill.

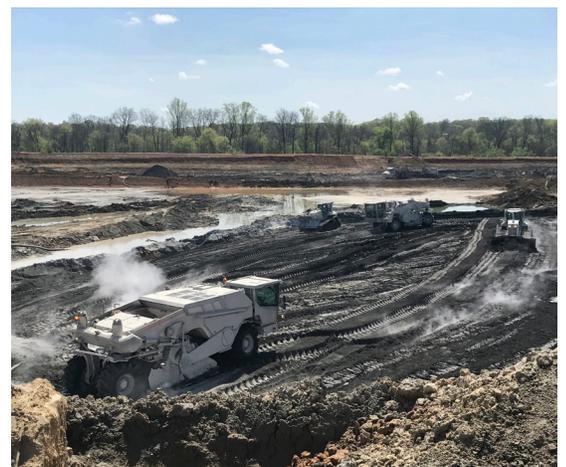
Lime Fines being mixed into the Ash with a Reclaimer
